CALIFORNIA BLACK OAK DRYING PROBLEMS AND THE BACTERIAL FACTOR.(U)

Research
Paper
FPL 344
1979

California Black Oak Drying Problems and The Bacterial Factor.

10 James C. Ward
Del/Shedd

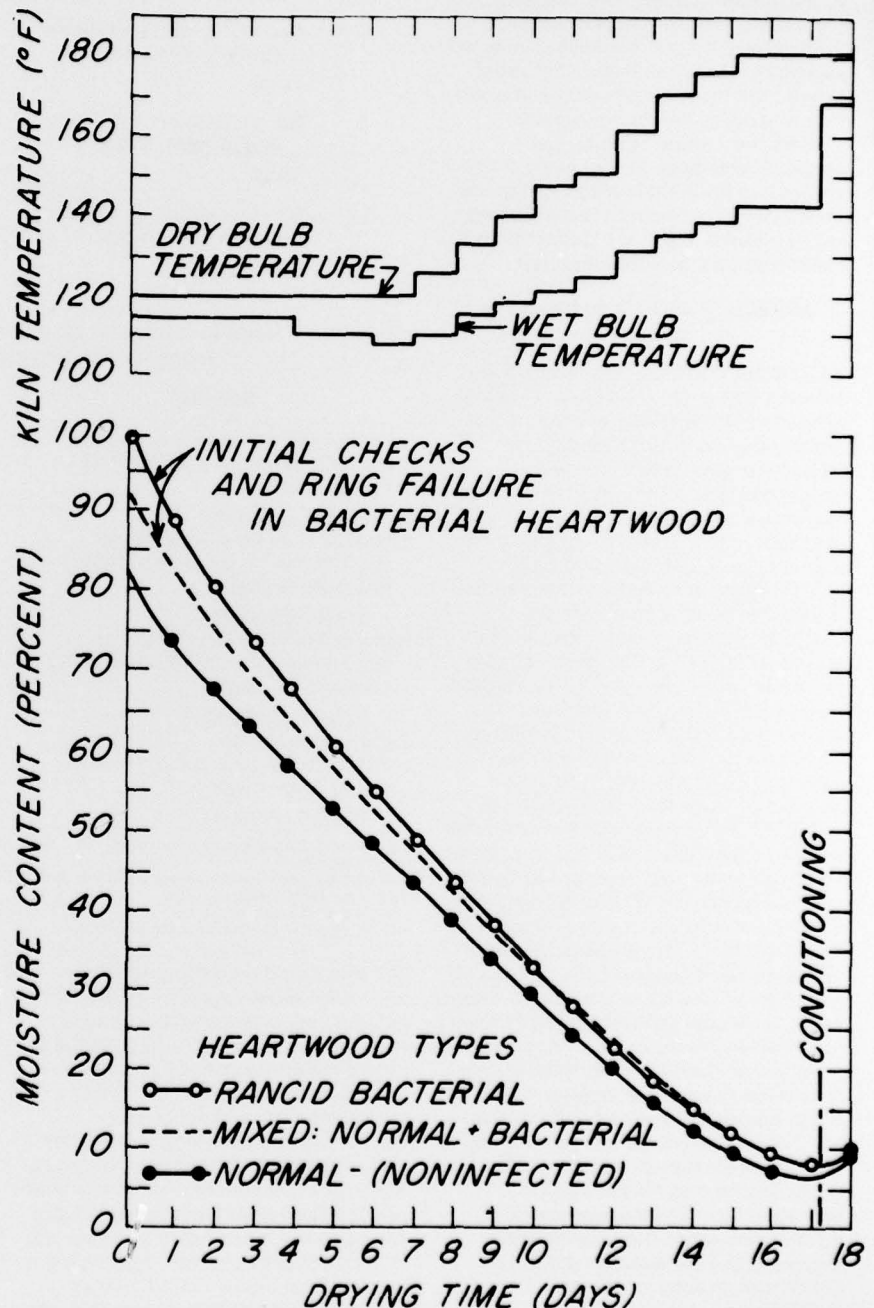
Experimental drying conditions and moisture loss curves for the green boards shipped to FPL are shown in figure 2 for simulated kiln drying and in figure 3 for air drying. Under both drying conditions, surface checking started in about 24 hours in bacterially infected heartwood of the rancid sample and the mixed wood sample. The initial air drying conditions were quite mild but not enough to prevent surface checking in bacterial heartwood. Normal, noninfected heartwood did not develop surface checks under either air drying or kiln drying. Ellwood (1959b) observed that most surface checking occurred in green flatsawn California black oak on the first day of kiln drying.

These laboratory drying experiments demonstrate that the normal, noninfected heartwood of California black oak can be kiln dried green from the saw without defects even under an initial temperature of 120° F. This compares with the first test of the large-

Figure 2.—Experimental kiln conditions and drying curves for 4/4 California black oak. (M 146 707)

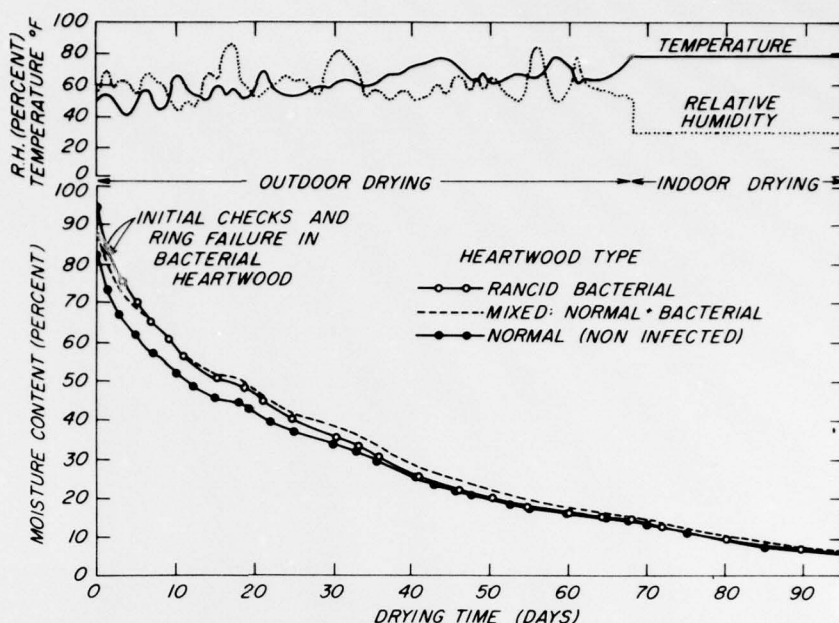
Figure 3.—Atmospheric conditions and air-drying curves for 4/4 California black oak. (M 146 705)
